# BANCROFT

## MILL ENGINE TRUST

### THE WHITELEES BEAM ENGINE AT ELLEN ROAD.

### The Whitelees Beam Engine

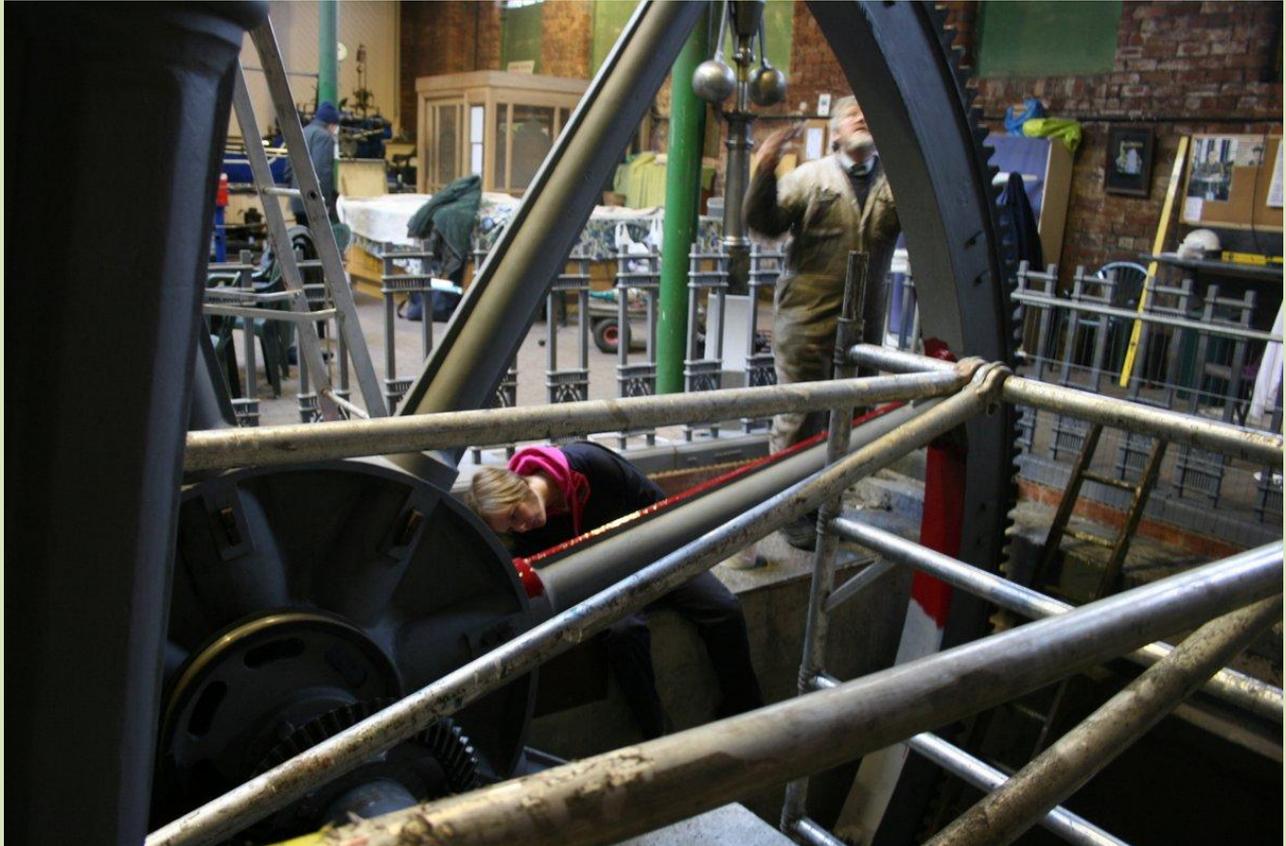
In fact the work required has been very extensive indeed and it is now hoped to complete the engine ready to run in March 2013. Picture below was taken during December 2012 and shows member Mrs. Renshaw applying paint to the flywheel. Picture: also by J. K. Wilson.

At the moment the whole engine is in the process of being thoroughly cleaned down, scraped and ready for repainting. During this process we discovered odd pockets of original coloured paintwork and we intend to use these to recreate its original colour scheme.
