How to Splice Driving Ropes.

AGM Update

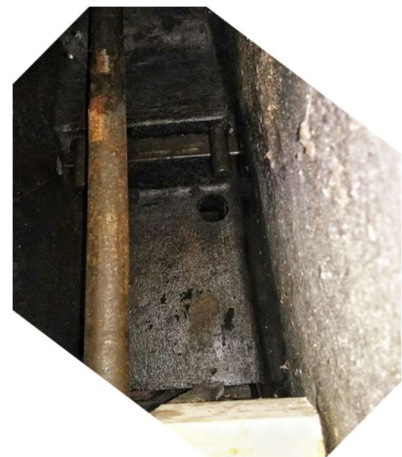
The oil leak on the crank end of the main-shaft on the Eastwood engine had still been causing concern and young Phil and Jim H had been struggling desperately to sort out the problem, and at the last Steam Day it appeared that all their work had been successful. It is not an easy place to work as this photo tries to show. The vertical metal rod in this picture is one of the hold down bolts for the main bearing, the lighter vertical surface to the right is the wall of the bed casting – the crank is on the other side of this surface to the right. The photo was taken holding the camera up against a gap less than two inches wide. It was through this gap that they had first managed to arrange a drip tray to collect the leaking oil before they finally managed to find the source of the leak above. Well done, those men.

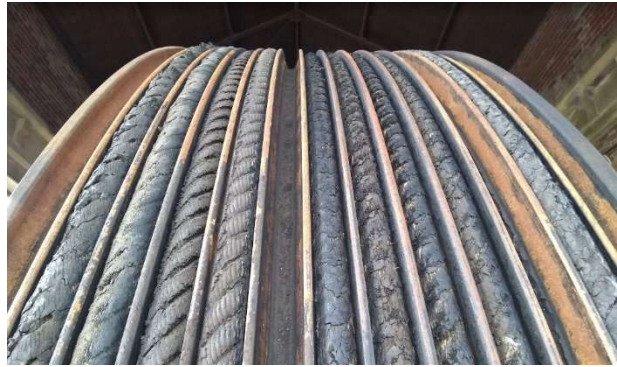
Something we always have to keep an eye on is the rope-drive from the Roberts engine to the second-motion wheel. If it ever became necessary to replace any of them, where would one find cotton rope and the skill to splice it? Not so easy in this world of electronics and hydraulic transmission.

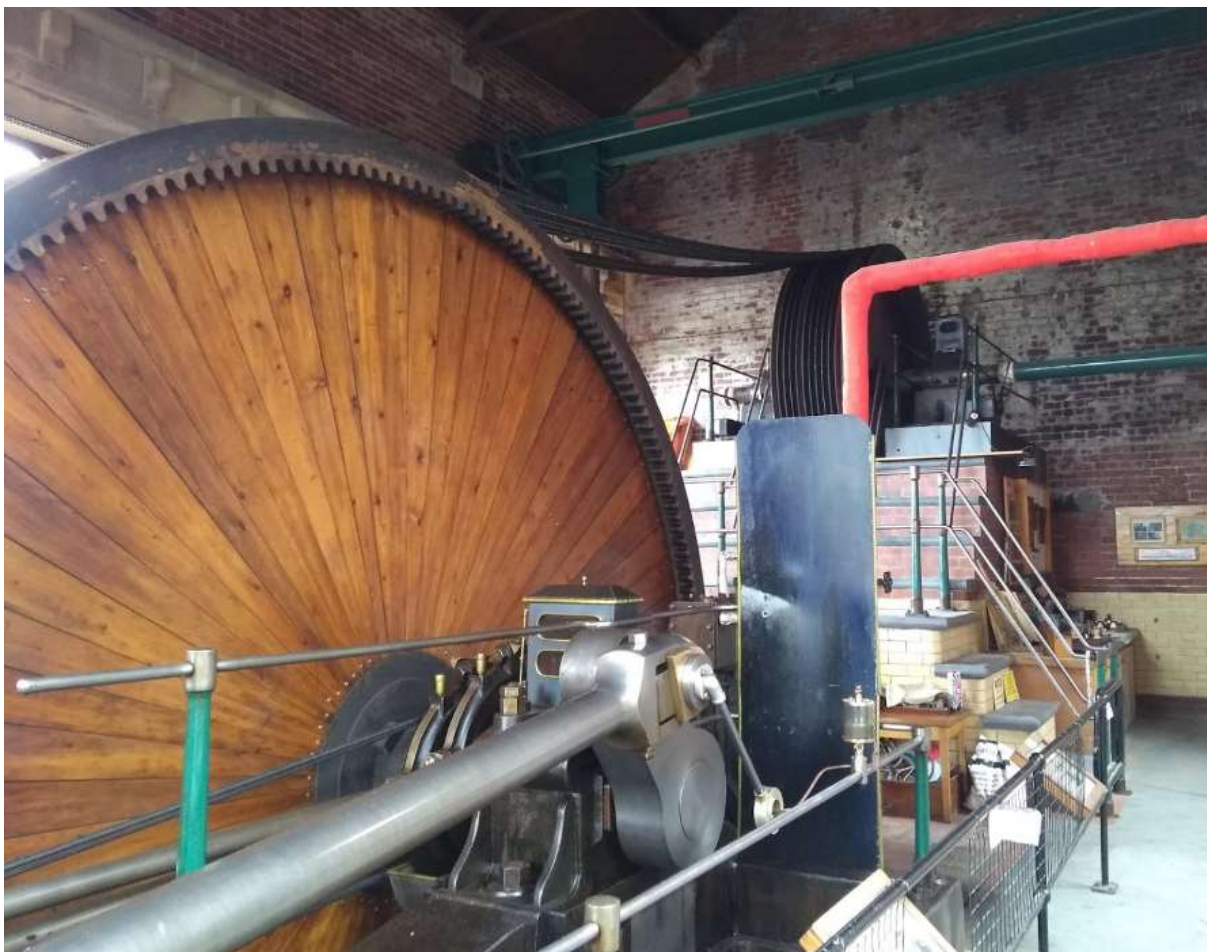
The first rope drives were made from hemp, which proved to be only moderately successful because the life of such a rope was quite short. During the nineteenth century, cotton ropes were found to be far superior and became the mainstay (no pun intended) of the

textile industry. In the English system a number of belts or ropes were installed in parallel, each carrying a part of the load. The American system used only one rope, wrapped round and round the drive pulleys and joined at one end. It was much cheaper to install, but of course if the rope breaks, everything stops, whereas in the English system one rope breaking simply meant that the other ropes each shouldered a bit more of the load and you could carry on at least for a while. If cotton ropes are looked after and kept water-proofed, they can last an amazingly long time in service. They are far more flexible and elastic than any other fibre, and can be used without problems on all sizes of pulley wheels and on very short-centred drives, as well as over long distances. The rope drive on our Roberts engine is particularly short at about 21' 6" horizontally and 8' vertically.
