BANCROFT MILL ENGINE MUSEUM

20th May 2013

Maintenance.

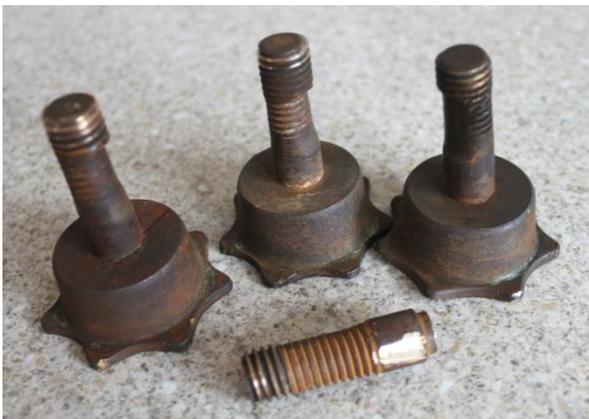
A couple of "steamings" ago we were obliged to change one of the valve groups in the boiler feed pump whilst warming up due to a catastrophic failure of one valve. Removal of the cover revealed a scene of near-devastation, luckily we have an identical spare pump and thus were running again quickly. The wear on the brass stems can be clearly seen and the stem in the foreground had parted from its spring retaining cap, locknuts had not been refitted to the stems when it was last serviced.

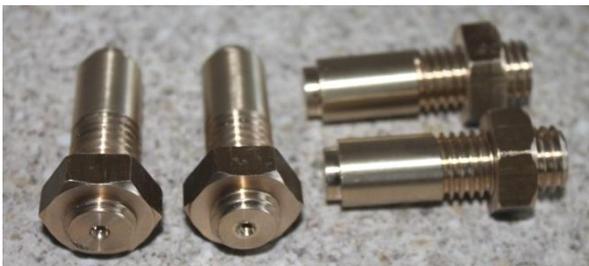
New stems (9/16 BSW) were turned and screwed , new locknuts made, all prior to brazing the caps on to them. The seating surfaces had suffered from a little wear and distortion due to age related stress relief of the sand castings that had been used. Lapping restored the geometry and promises reliable sealing under working conditions.

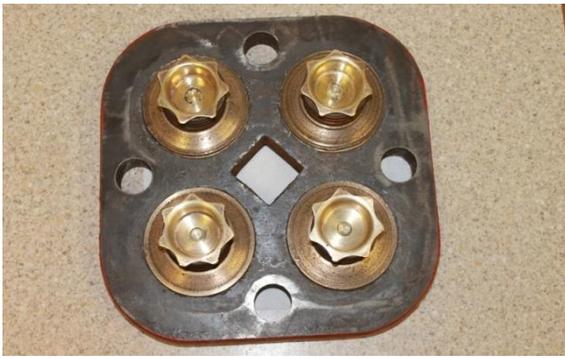
The overhauled valves are now replaced in their carrier casting (left).

Removal of the cast brass valve seats, which were taper threaded around 3.5 inches diameter, was difficult as they had been fitted after coating with sealant. A special tool was made for the purpose with a *very* long arm. Using a combination of freezing and heating the tool eventually removed the seats to allow the reseating.

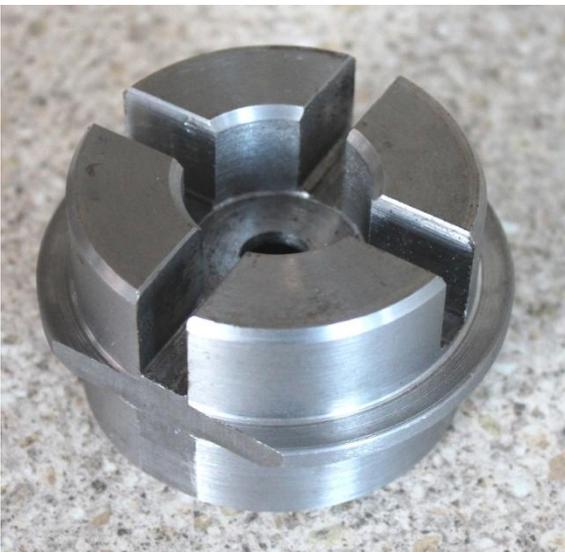
Left:

The business end of the tool before attaching its long arm, slots arranged in a cruciform shape engage with four arms in the casting and thus removed the parts safely. It is made from mild-steel.
